# TANK PUMPING REPORT

Location: 1156 RIDGEWAY DR  
OAK HARBOR  
Tax ID: S8390-00-00007-0  
Use:

### Dirty Deeds Septic Services

Serviced: 09/24/2025 by: Keith Jordan

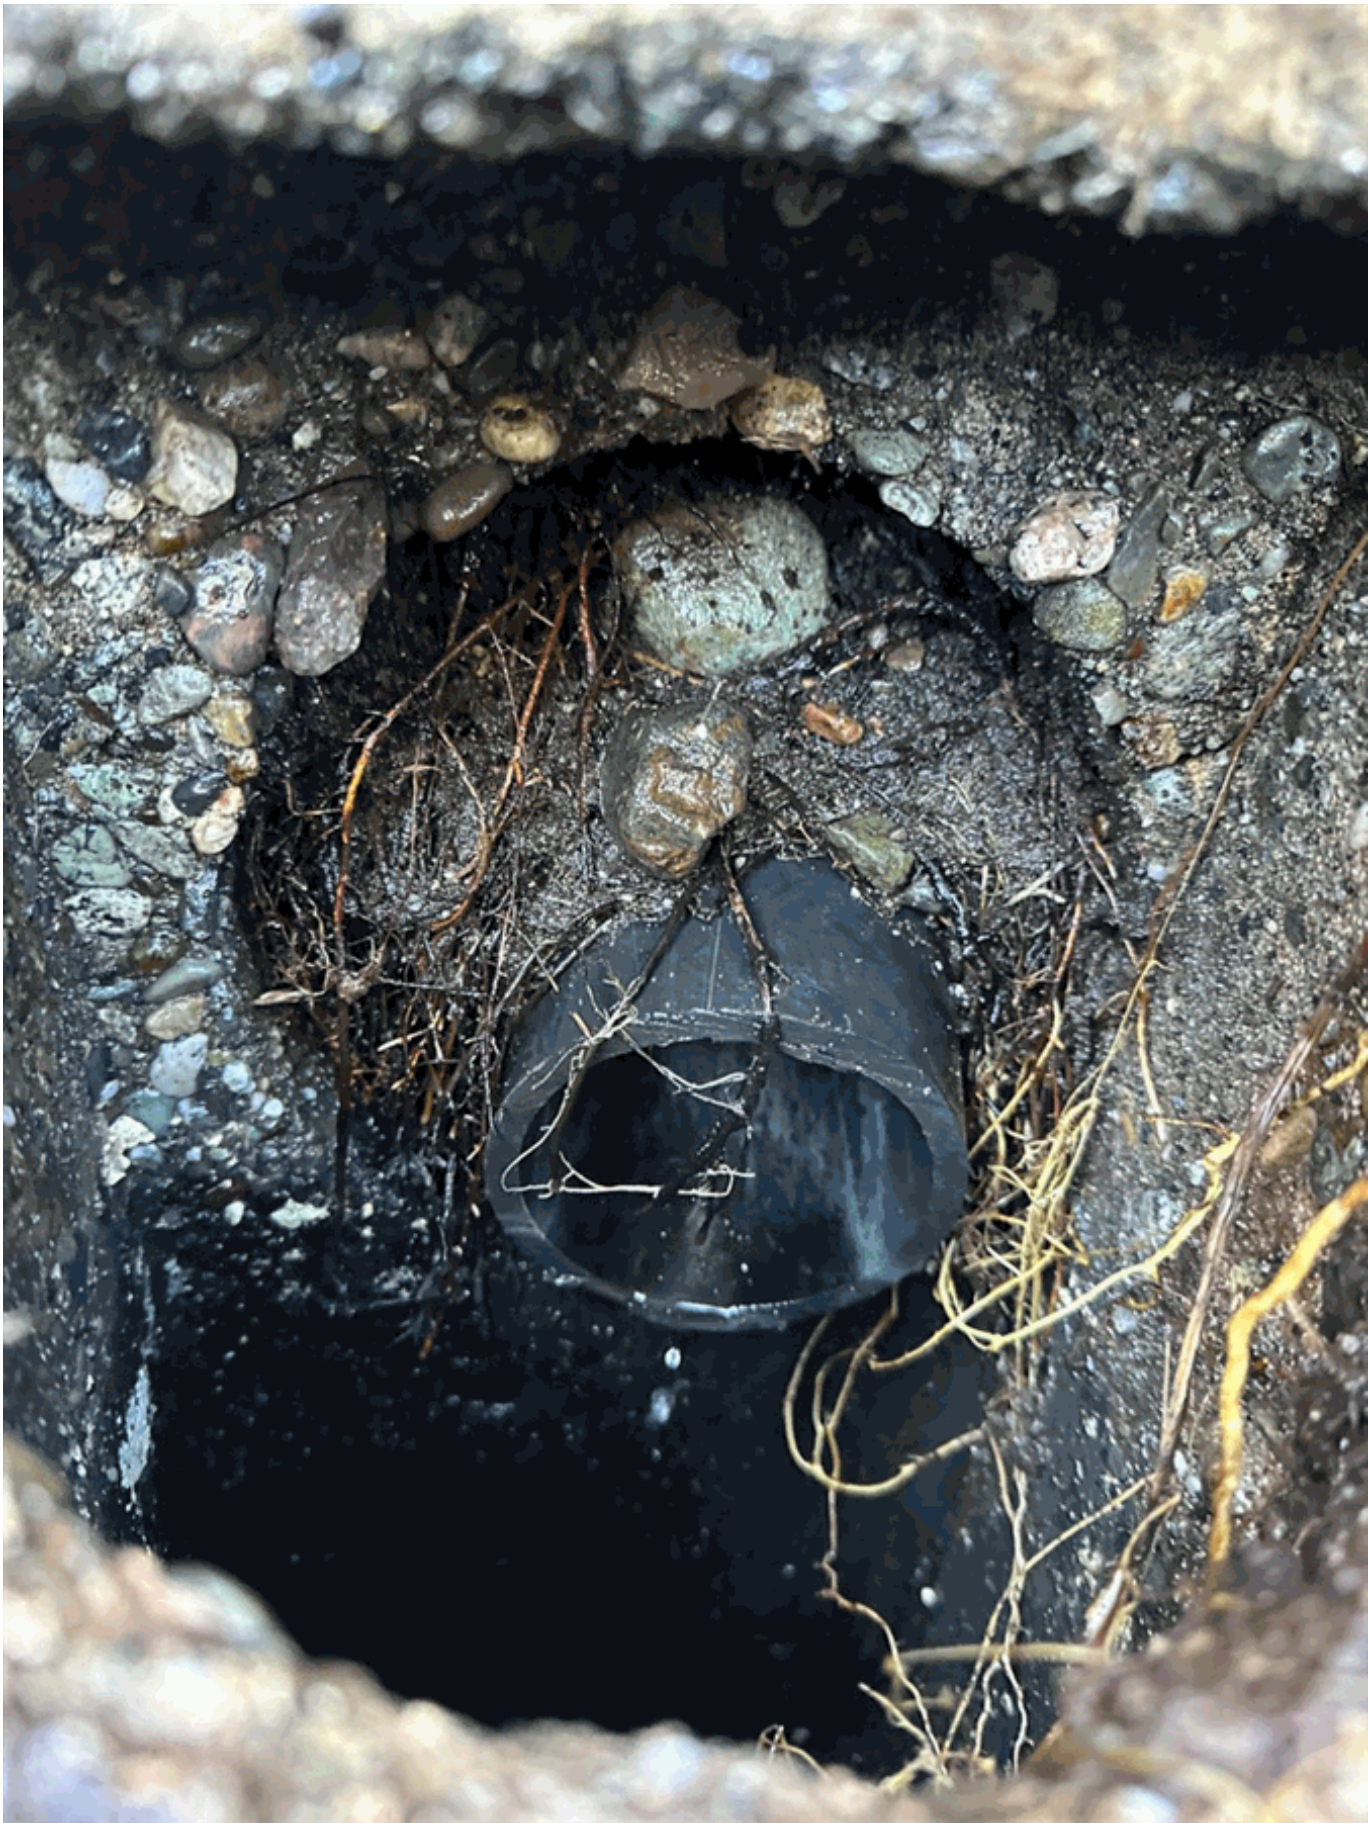
Septic tank is not in good condition and has deterioration and root intrusion around inlet and outlet.

Penetration points for the inlet and outlet both are not sealed.

Septic tank lid has radiating cracks throughout the lid that travel from inlet to outlet.

The on-site sewage system will require an inspection and then evaluation by a septic designer. The reported conditions and deficiencies from this pumping report and future inspection report, will assist in determining corrective actions.
